F-111C Lower Wing Skin Bonded
Composite Repair Substantiation
Testing

R. Boykett and K. Walker

DSTO-TR-0480

This report documents the results of a comprehensive testing program for the substantiation of a bonded boron epoxy patch repair to a fatigue crack in the lower wing skin of an F-111C aircraft (A8-145) in the Royal Australian Air Force. The fatigue crack was a chordwise 48 mm crack in the critical, non-failsafe, port lower wing skin at approximately 2/3 semi span. The crack had reduced the wing's residual strength to below Design Limit Load and the repair was therefore critical; the options were to scrap the whole wing or apply a bonded repair. This repair represents the most critical application of bonded repair technology yet undertaken anywhere in the world.

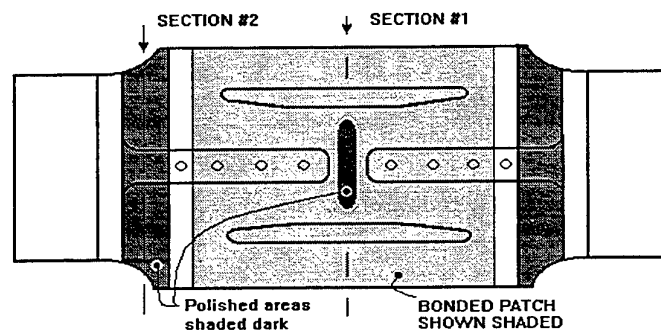
Figure 5. Panel specimen.
View onto side representing upper surface of lower wing skin.
Boron/Epoxy patch is bonded to side representing lower surface.

Several test specimens failed outside the test area. Two panel specimens failed under static loading in the tapered region close to the grips of the testing machine¹⁴. These were attributed to stress concentrations due to the changes in geometry. Referring to Figure 5, the cross-sectional area at section 2 (less than 828.6 mm²) is smaller than that at section 1 (829.2 mm²), when there is no crack. Also, a repaired panel specimen (patched and cracked) may be weaker outside the patch, without some treatment of the area in section 2. Later panel specimens were then polished and shot-peened in the area of section 2 to prevent this type of failure.

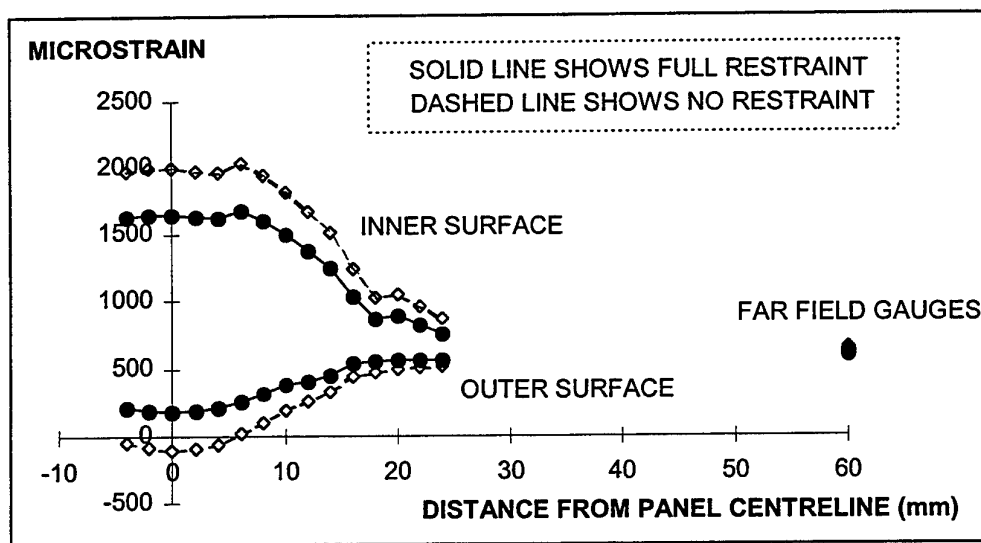
Figure 7. Chordwise strain distribution at 20% DLL (after CPLT case)

Note that the high strain variation reduces to within 25% of the nominal (far-field) value within 20 mm of the panel centreline (representing the spanwise spar line). The crack in RAAF aircraft A8-145 was 48 mm tip-to-tip (symmetrical about the spar line).

Note also that the peak strain on the inner surface at 20% DLL is approximately 1600 microstrain. Assuming a linear relationship with loading, this equates to approximately 8000 microstrain at 100% DLL, which is well in excess of the uni-axial yield strain for the material of 5500 microstrain. Even allowing for some degree of non-linearity, this result indicates that significant yielding can be expected in the area

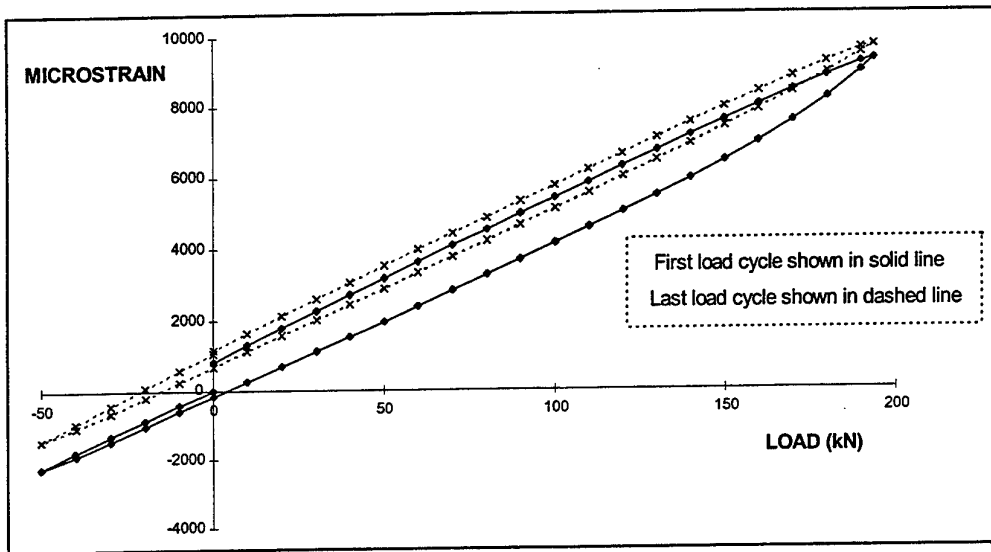
Figure 8. Panel specimen during CPLT load case (strain gauge SO5A-3 at centreline on side representing upper surface of lower wing skin).

Note that there is non-linear deformation in this area (where the cracking initiates) when first loaded above 70% DLL (149 kN). This effect is followed by hysteresis and residual tensile strain of 1100 microstrain.

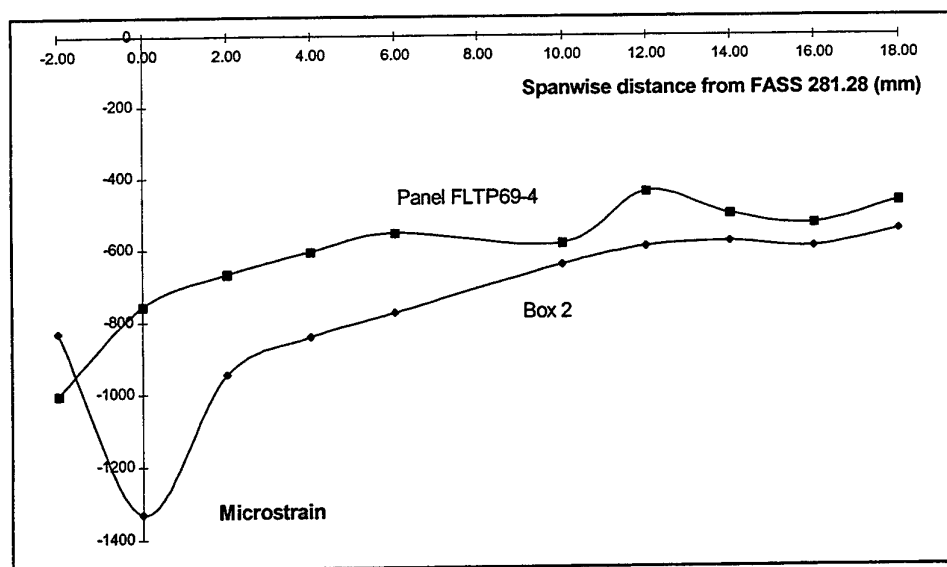
Figure 13. Residual strain distribution at zero load, ambient temperature

The residual thermal strain distribution in the boron patch is similar for both box and panel types of specimens. The residual strain in the aluminium structure would be expected to be a similar level but tensile. This significant level of residual tensile strain in the local region of the crack could be expected to have the effect of increasing the stress ratio, R .

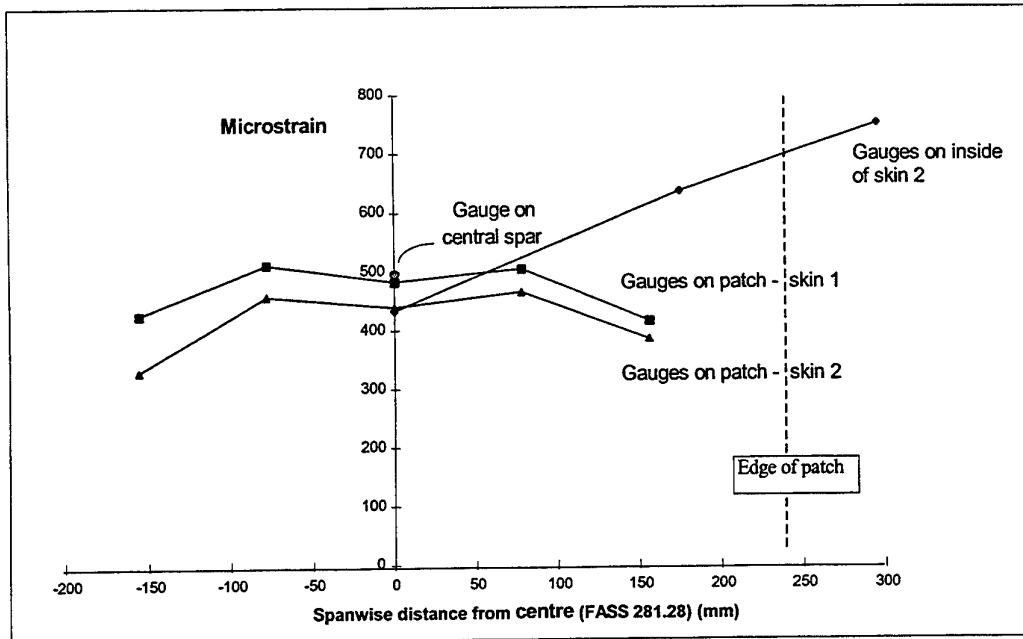
Figure 18. Strain distribution at 20% D.L.L. of fully assembled box specimen prior to fatigue spectrum loading.
Refer to Appendix 4 for strain gauge labelling and locations.

At the centre of the specimen, the strain in the patch, the skin panel and the central spar/web are within 10%, indicating that the load is evenly distributed between the three elements. Most of the load transfer from the aluminium skins into the boron patch has occurred within 90 mm from end of the patch. There is no evidence of load transfer within 70 mm of either side of the crack at the centre (FASS 281.28).
